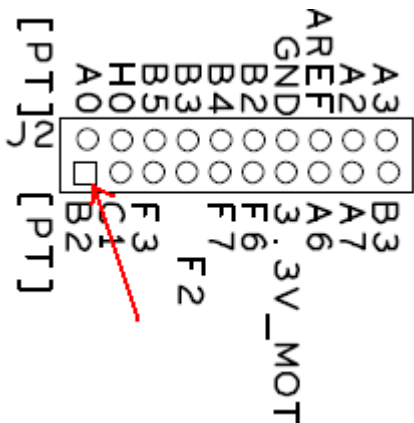
Figure 2: Correct Pin1 Identifier of J2

The correct position should be:

All the pin names are correct. This pin1 identifier error will not impact any functions of the board.

**Workaround:**None

**Fix Plan:** Has fixed on FRDM-KE02Z (700 Assembly Rev A) without TDA4613.
